# Structural Engineers Report For:

Jubilee Park Concrete Flood Wall, Rogerstone

## STRUCTURAL REPORT

**RE: Structural Inspection at Jubilee Park, Rogerstone**

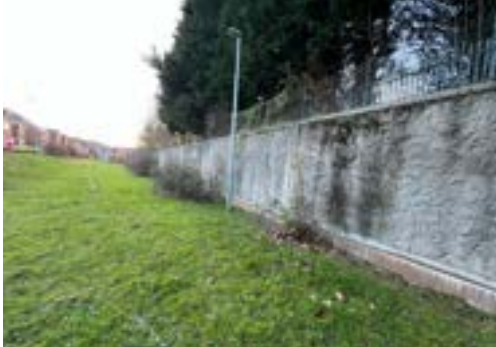
<p><b>Location:</b> 10.0m (Front Elevation)</p> <p><b>Observation:</b> No defects noted.</p>

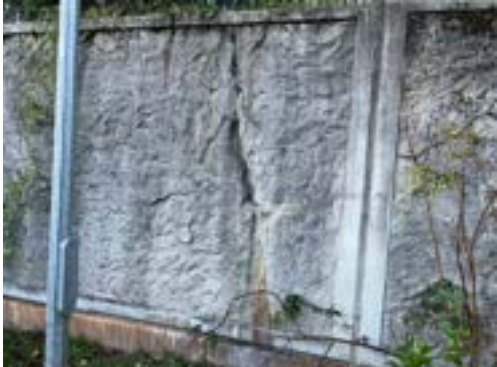
2

<p><b>Location:</b> 15.0m (Front Elevation)</p> <p><b>Observation:</b> Vertical cracking through full height of wall, cracking approximately 1-2mm in width.</p>
3

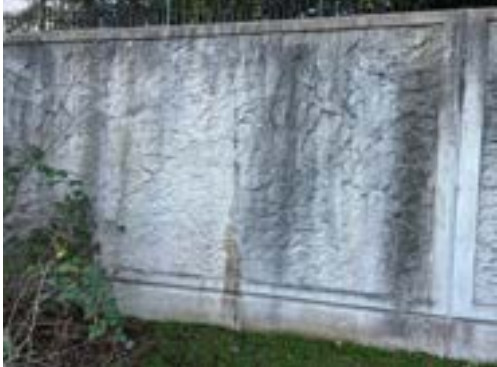
<p><b>Location:</b> 35.0m (Front Elevation)</p> <p><b>Observation:</b> Vertical cracking through full height of wall, cracking approximately 1-2mm in width.</p>
4

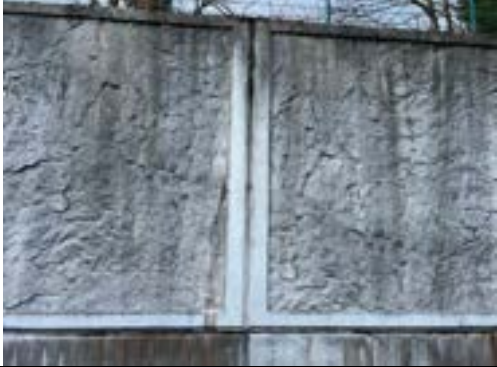
<p><b>Location:</b> 100.0m (Front Elevation)</p> <p><b>Observation:</b> Vertical cracking through full height of wall localised around joint, cracking approximately 1-2mm in width.</p>
5

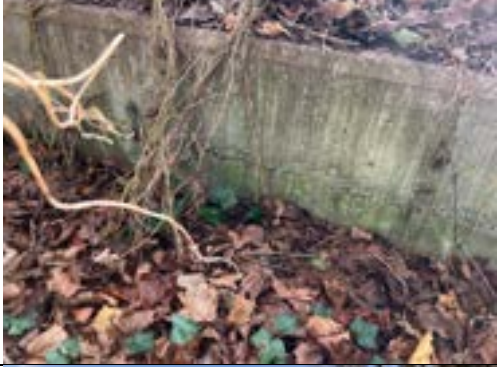
<p><b>Location:</b> 45.0m (Rear Elevation)</p> <p><b>Observation:</b> Surface damage noted around top of wall, damage continues horizontally for approximately 5.0m.</p>
6

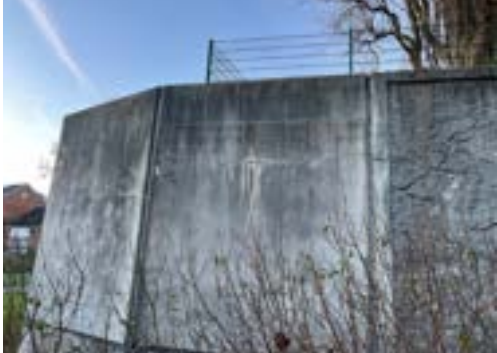
<p><b>Location:</b> 108.0m (Front Elevation)</p> <p><b>Observation:</b> Horizontal cracking through section of wall, cracking approximately 1-2m in width</p>

The various horizontal cracks noted to the front and rear elevation, mostly localised around joints in the wall, are considered to not be of adverse structural concern. The cracks are likely formed by minor differential settlement of the foundations and seasonal thermal movement. It is our recommendation that these cracks continue to be monitored and reassessed in 18-24 months, to confirm if the cracks are progressive and require remedial works to prevent the likelihood of further cracking. Wherever cracks are deemed to be non-progressive or related to thermal movement, they should be filled with a non-shrink grout to prevent water ingress and likely damage due to frost/thaw effects. Where cracking has been noted at collapsed trees, we recommend that the trees are removed from the wall and the cracks are also filled with a non-shrink grout.

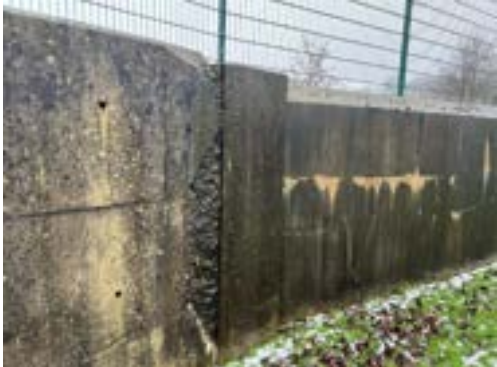
7

<p><b>Location:</b> 140.0m (Rear Elevation)</p> <p><b>Observation:</b> Hairline cracking noted across wall.</p>
8

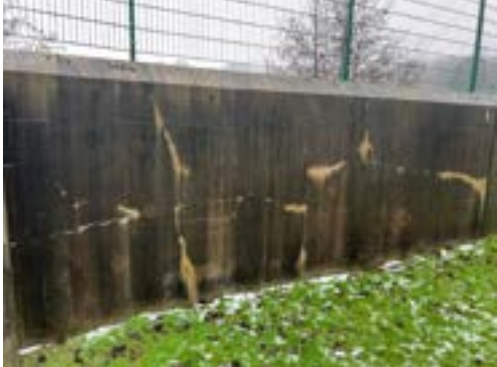
<p><b>Location:</b> 155.0m (Rear Elevation)</p> <p><b>Observation:</b> Various hairline cracking across wall.</p>
9

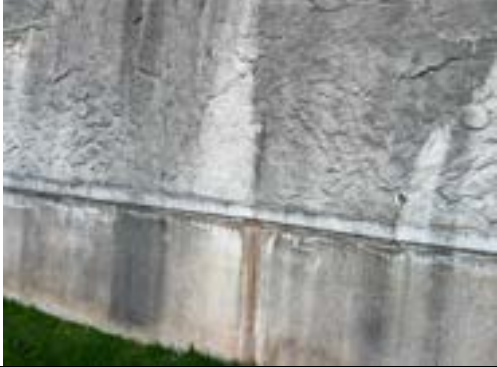
<p><b>Location:</b> 160.0m (Front Elevation)</p> <p><b>Observation:</b> Vertical cracking through full height of wall, cracking was hairline in width at a high level and approximately 1-3mm at the base.</p>
10

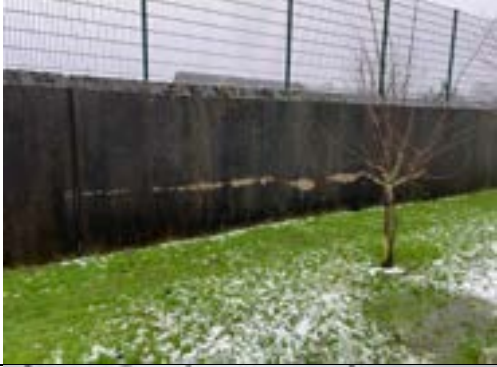
<p><b>Location:</b> 190.0m (Rear Elevation)</p> <p><b>Observation:</b> Horizontal hairline cracking noted across wall.</p>
11

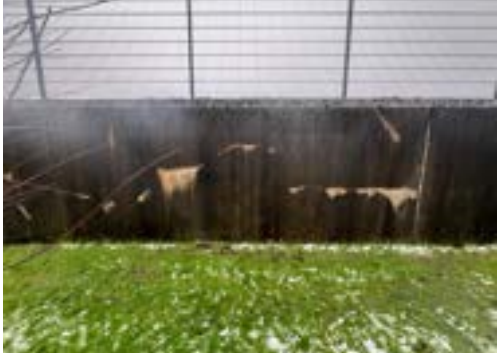
<p><b>Location:</b> 255.0m (Rear Elevation)</p> <p><b>Observation:</b> Horizontal hairline cracking noted across wall.</p>

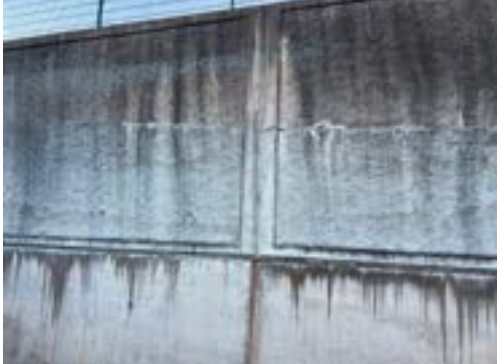
12

<p><b>Location:</b> 275.0m (Front Elevation)</p> <p><b>Observation:</b> Vertical cracking through full height of wall localised around joint, cracking was approximately 2-3mm in width, horizontal cracking also noted across sections of wall.</p>
13

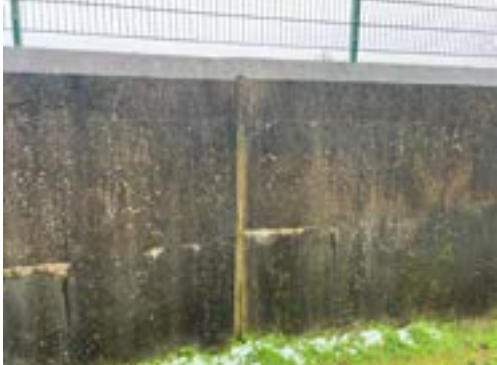
<p><b>Location:</b> 280.0m (Rear Elevation)</p> <p><b>Observation:</b> Horizontal crack through full height of wall localised around joint, crack was approximately 2-3mm in width.</p>
14

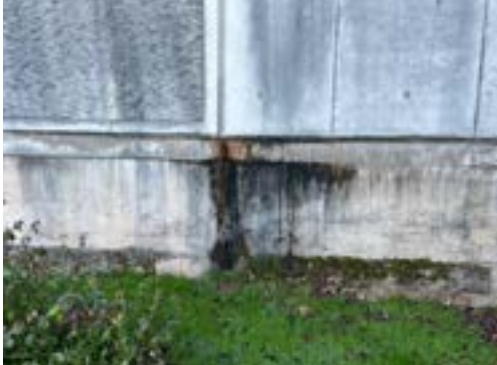
<p><b>Location:</b> 340.0m (Front Elevation)</p> <p><b>Observation:</b> Horizontal cracking at base of wall, Seepage noted at joint between base and stem.</p>
15

Whilst the water staining noted at the joint between the stem and base, along the front elevation of the flood defense wall may be unsightly, we do not consider the noted seepage to be of adverse structural concern. The seepage is likely due to defective or damaged waterproofing at the joint between the stem and base of the wall. We would also recommend that these areas be monitored over an extended period

of time to confirm that no adverse cracking or spalling concrete forms around the areas of water seepage. Should defects begin to arise in these areas we would recommend that local excavation be undertaken to the rear elevation of the wall, exposing the joint between the stem and base to allow for adequate waterproofing to be installed.

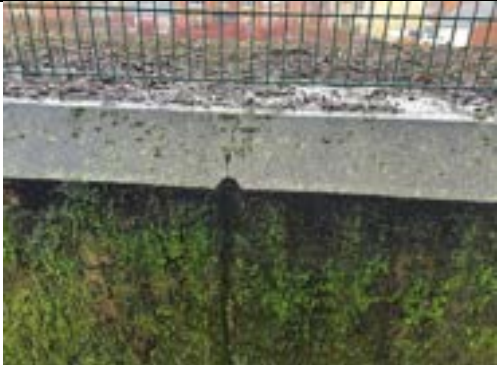
<p><b>Location:</b> 360.0m (Rear Elevation)</p> <p><b>Observation:</b> Vertical crack through full height of wall localised around joint, crack was approximately 2-3mm in width.</p>
16

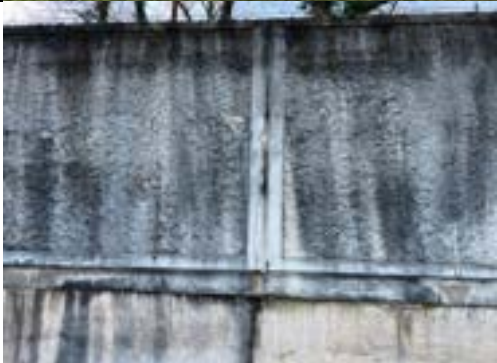
<p><b>Location:</b> 380.0m (Front Elevation)</p> <p><b>Observation:</b> Vertical cracking through full height of wall localised around joint, cracking was approximately 2-3mm in width.</p>

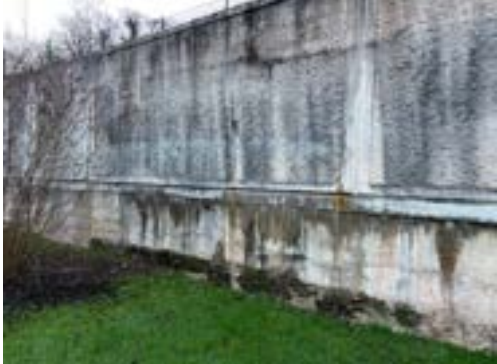
17

<p><b>Location:</b> 405.0m (Front Elevation)</p> <p><b>Observation:</b> Horizontal cracking at base of wall, seepage noted between the base and stem.</p>
18

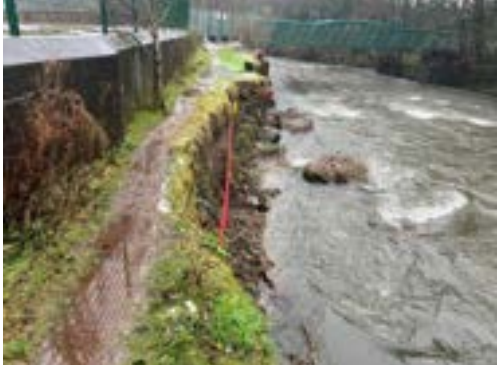
Extensive riverbank erosion from the Ebbw River has led to an approximately 25.0m section of footpath collapsing. The collapse is to the rear of the wall, located at a chainage of approximately 410.0m.

<p><b>Location:</b> 405.0m (Rear Elevation)</p> <p><b>Observation:</b> Section of path has collapsed into the river.</p>
19

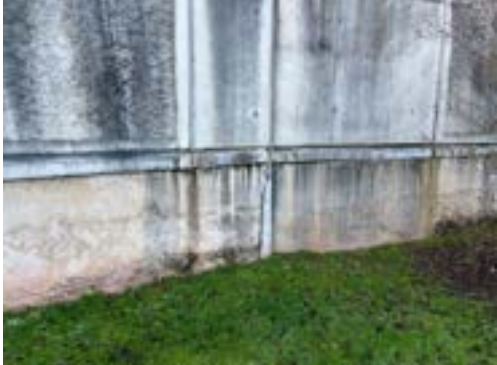
<p><b>Location:</b> 420.0m (Front Elevation)</p> <p><b>Observation:</b> Vertical cracking noted at the base of the wall localised around joint, cracking was approximately 2-4mm in width.</p>
20

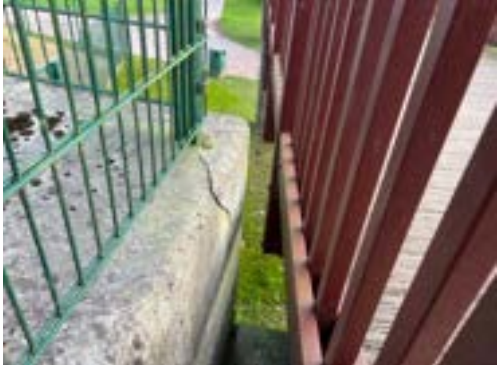
<p><b>Location:</b> 430.0m (Front Elevation)</p> <p><b>Observation:</b> Cracking noted around post base, cracking was approximately 1-5mm in width and was noted to various post bases</p>
21

Where cracking has been noted around post bases of the guard fences, these are likely caused by the fenceposts being cast without enough cover to the edge of the concrete, the cracking may also be being exacerbated by the posts and fences being climbed on. We recommend the cracking of the corner fence post bases, local to the Jubilee Park footbridge, are repaired using a concrete crack repair solution, such as those provided by Sika. Should the cracking continue, we would recommend that the corners be mechanically fixed back to the surrounding concrete, using a crack repair kit such as those provided by Helifix.

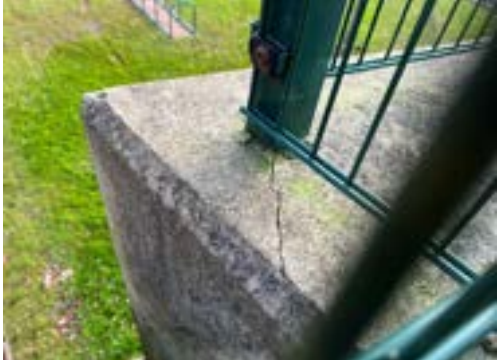
<p><b>Location:</b> 433.0m (Front Elevation)</p> <p><b>Observation:</b> Cracking noted around post base, cracking was approximately 1-3mm in width and was noted to various post bases</p>

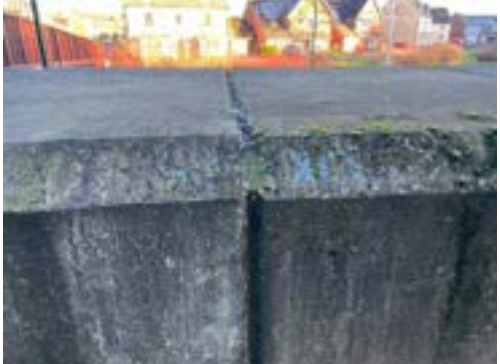
22

<p><b>Location:</b> 435.0m (Rear Elevation)</p> <p><b>Observation:</b> Vertical crack localised around joint, crack was approximately 1-2mm in width.</p>
23

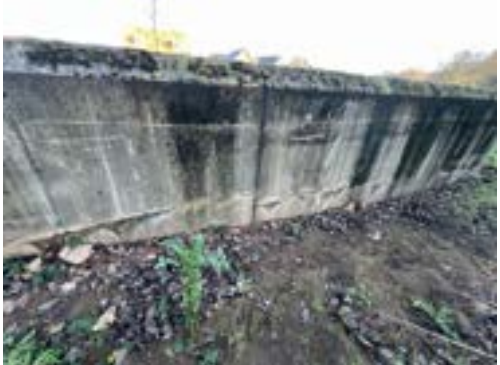
<p><b>Location:</b> 440.0m (Rear Elevation)</p> <p><b>Observation:</b> Horizontal cracking noted across wall sections, cracking was hairline in width.</p>
24

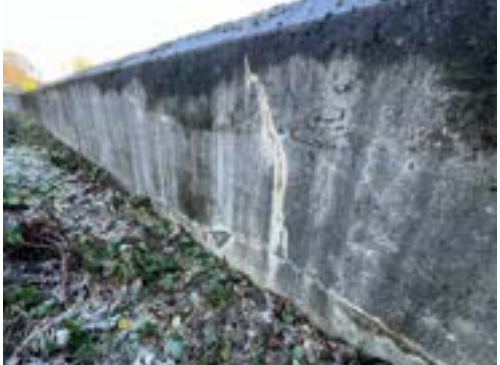
<p><b>Location:</b> 490.0m (Rear Elevation)</p> <p><b>Observation:</b> Vertical and horizontal hairline cracking noted across wall.</p>
25

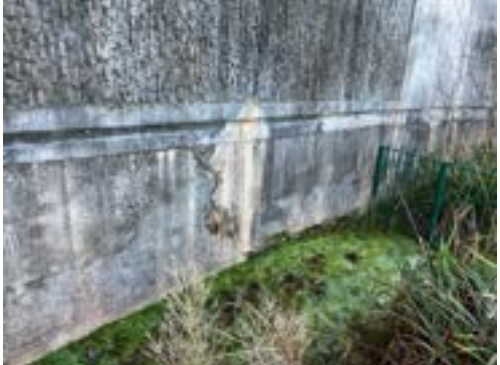
<p><b>Location:</b> 505.0m (Front Elevation)</p> <p><b>Observation:</b> Cracking noted at base of wall, cracking was approximately 1-3mm in width.</p>
26

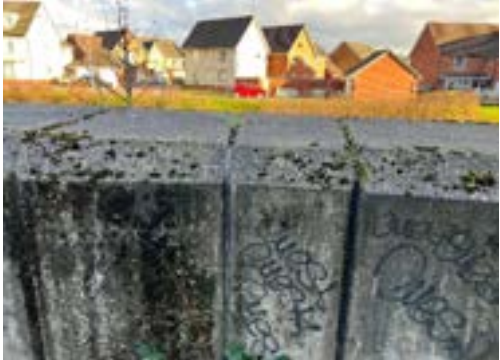
<p><b>Location:</b> 560.0m (Rear Elevation)</p> <p><b>Observation:</b> Vegetation growth within movement joint.</p>

We recommend that where noted, the vegetation growth within the movement joints, mostly to the top of the wall be removed to prevent further damage via root ingress. The damaged sealant should be replaced wherever vegetation requires removal.

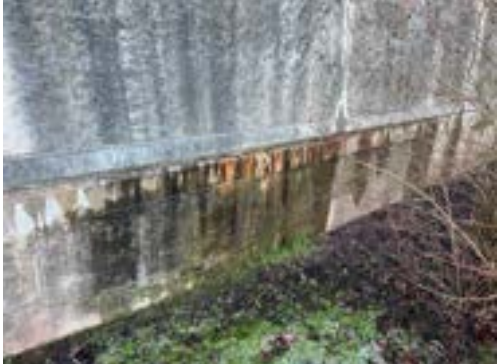
27

<p><b>Location:</b> 570.0m (Front Elevation)</p> <p><b>Observation:</b> Seepage noted between the base and stem.</p>
28

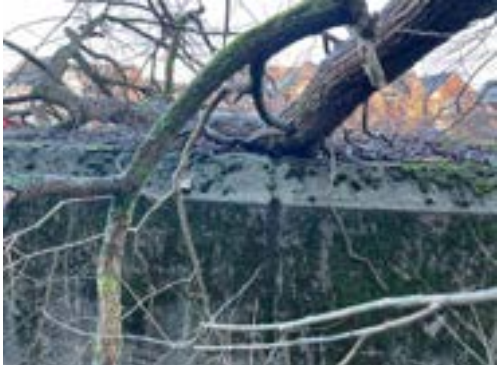
<p><b>Location:</b> 590.0m (Rear Elevation)</p> <p><b>Observation:</b> Vertical crack noted at joint where tree has collapsed, crack was approximately 1-2mm in width.</p>
29

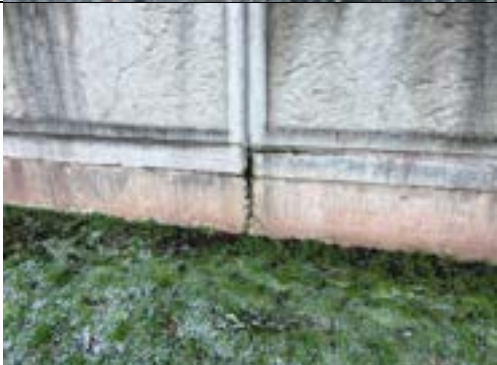
<p><b>Location:</b> 600.0m (Front Elevation)</p> <p><b>Observation:</b> Horizontal cracking noted at the base of the wall localised around joint, cracking was approximately 2-3mm in width.</p>
30

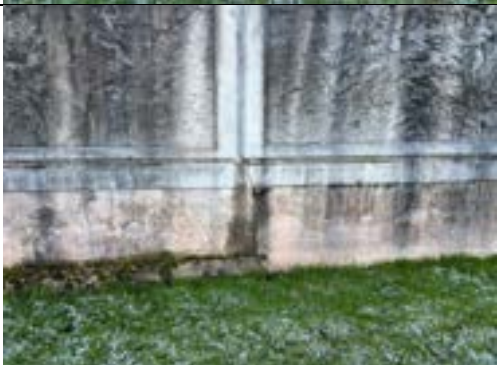
<p><b>Location:</b> 640.0m (Front Elevation)</p> <p><b>Observation:</b> Horizontal cracking noted at the base of the wall localised around joint, cracking was approximately 2-3mm in width.</p>
31

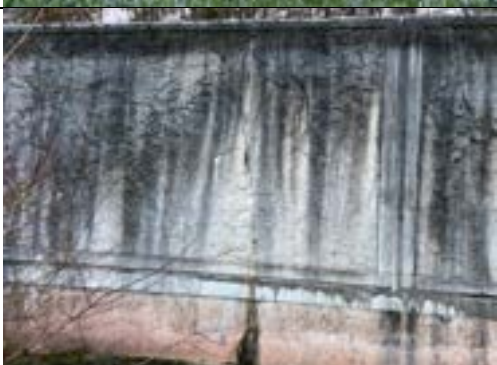
<p><b>Location:</b> 690.0m (Front Elevation)</p> <p><b>Observation:</b> Vertical cracking through full height of wall, cracking approximately 1-3mm in width.</p>

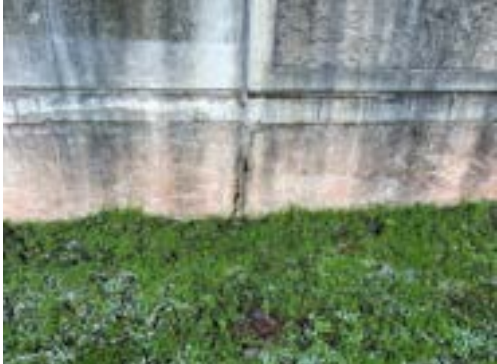
32

<p><b>Location:</b> 705.0m (Front Elevation)</p> <p><b>Observation:</b> Horizontal cracking noted at the base of the wall localised around joint, cracking was approximately 2-3mm in width.</p>
33

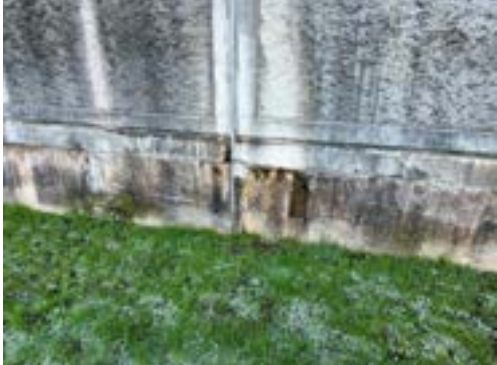
<p><b>Location:</b> 720.0m (Front Elevation)</p> <p><b>Observation:</b> Horizontal and vertical cracking noted at the base of the wall localised around joint, cracking was approximately 2-3mm in width.</p>
34

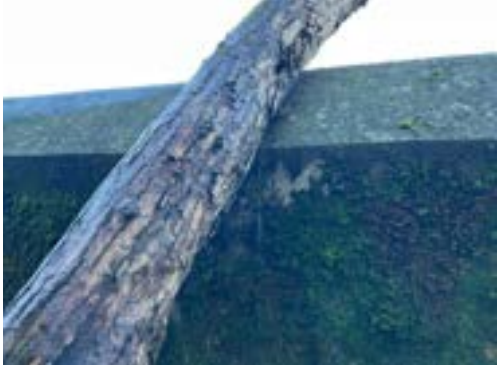
<p><b>Location:</b> 730.0m (Rear Elevation)</p> <p><b>Observation:</b> Vertical crack noted where tree has collapsed, crack was approximately 1-2mm in width.</p>
35

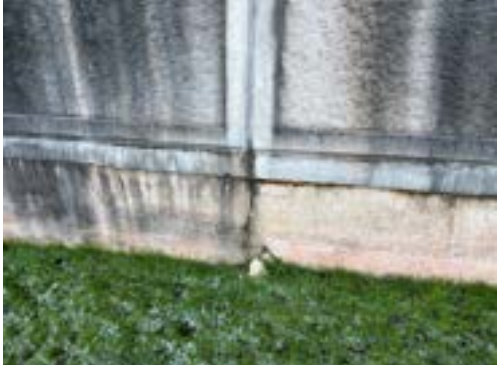
<p><b>Location:</b> 745.0m (Front Elevation)</p> <p><b>Observation:</b> Horizontal cracking noted at the base of the wall localised around joint, cracking was approximately 1-3mm in width.</p>
36

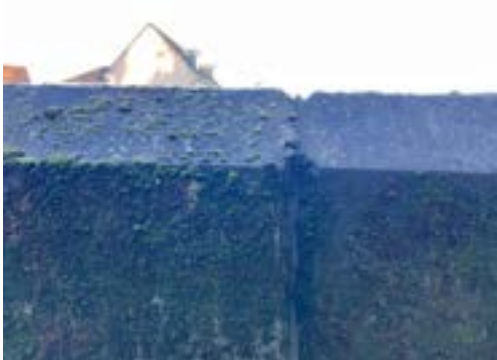
<p><b>Location:</b> 805.0m (Rear Elevation)</p> <p><b>Observation:</b> Vertical cracking through full height of wall localised around joint, crack was approximately 1-2mm in width.</p>

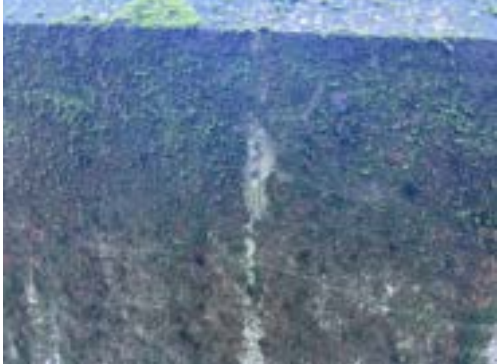
37

<p><b>Location:</b> 870.0m (Rear Elevation)</p> <p><b>Observation:</b> Vertical cracking through full height of wall, crack was approximately 1-2mm in width.</p>
38

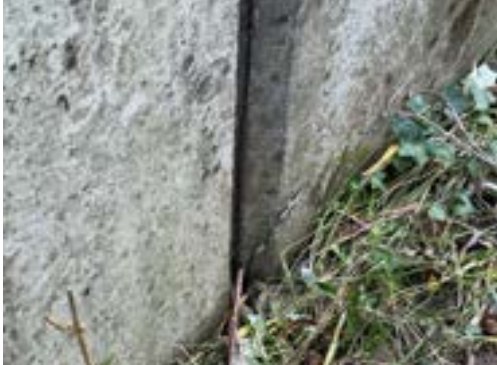
<p><b>Location:</b> 950.0m (Rear Elevation)</p> <p><b>Observation:</b> Cracking and spalling concrete at low level.</p>
39

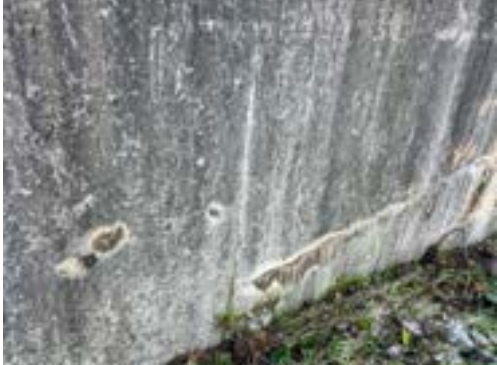
<p><b>Location:</b> 1050.0m (Rear Elevation)</p> <p><b>Observation:</b> Vertical and horizontal cracking noted across wall, cracking was hairline-1mm in width.</p>
40

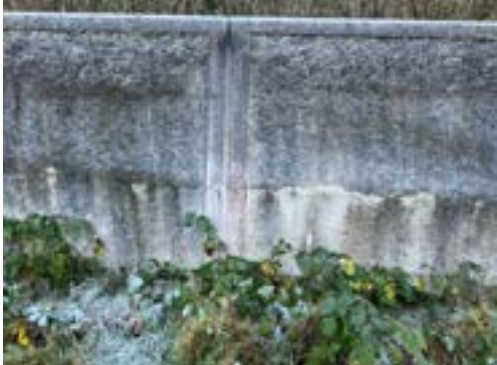
<p><b>Location:</b> 1300.0m (Front Elevation)</p> <p><b>Observation:</b> Horizontal cracking across wall panels, cracking was approximately hairline-1mm in width.</p>
41

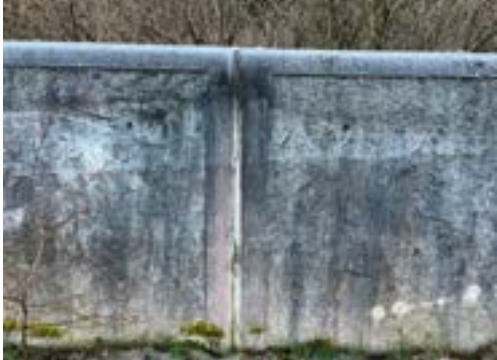
<p><b>Location:</b> 1480.0m (Front Elevation)</p> <p><b>Observation:</b> Vertical cracking through full height of wall localised around joint, cracking approximately 2-3mm in width.</p>

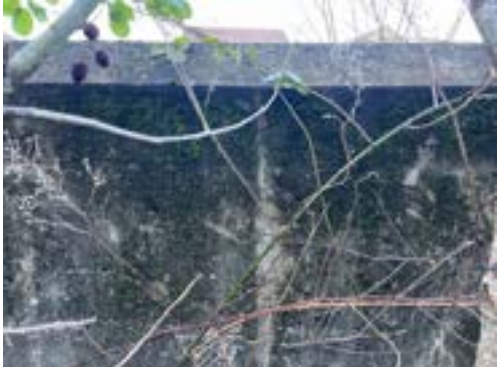
42

<p><b>Location:</b> 1550.0m (Rear Elevation)</p> <p><b>Observation:</b> Vertical cracking through full height of wall, crack was approximately 1-2mm in width.</p>
43

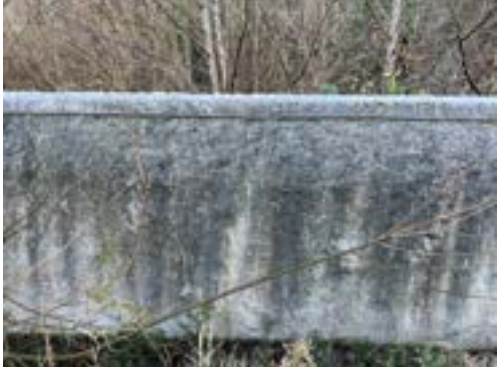
<p><b>Location:</b> 1560.0m (Front Elevation)</p> <p><b>Observation:</b> Vertical cracking through full height of wall localised around joint, cracking approximately 1-2mm in width.</p>
44

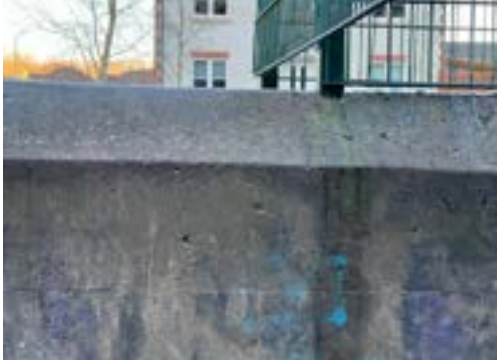
<p><b>Location:</b> 1600.0m (Rear Elevation)</p> <p><b>Observation:</b> Cracking noted around post base, cracking was approximately 1-2mm in width.</p>
